# BASTIÓN DE SAN DIEGO

INTRAMUROS ADMINISTRATION  
MINISTRY OF HUMAN SETTLEMENTS

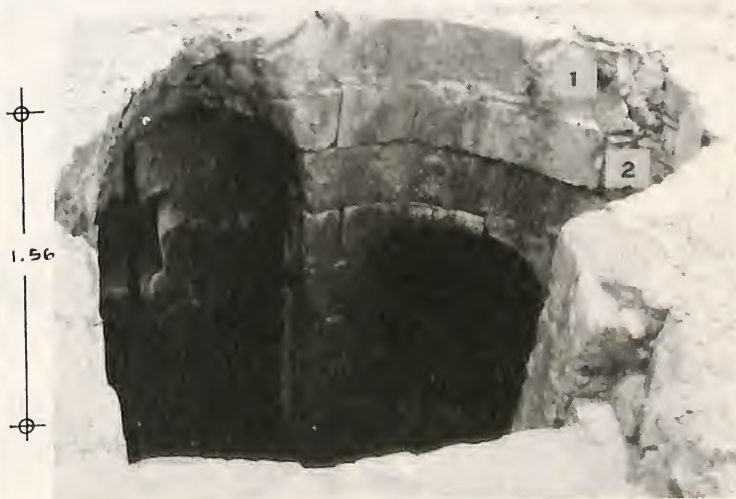
Figure 18. A view of the stairwell. Acroposts support some of the loose stones of the structure. Numbers one and two indicate missing stone members of the original winding staircase.

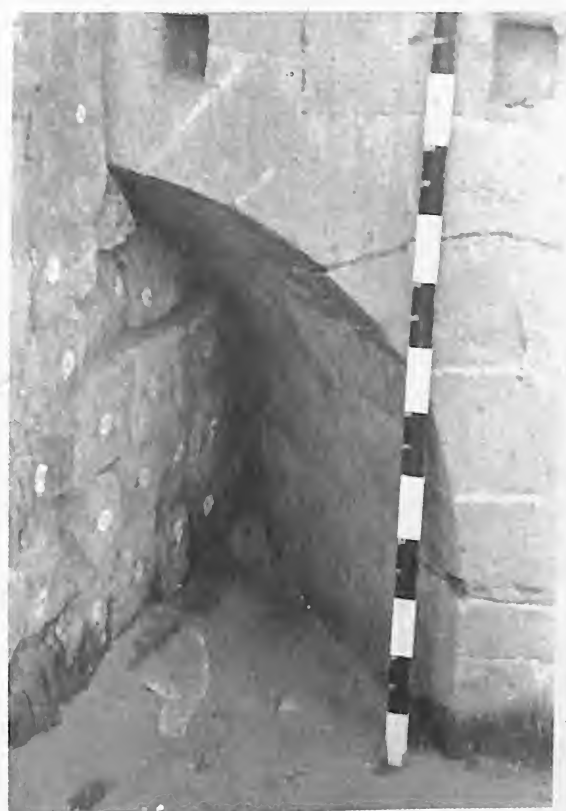
Figure 28. Casemate No. 7 has been totally obstructed by the spoke built right through its center. Like casemate No. 3, grooves on the outer wall by the entrance may be seen.

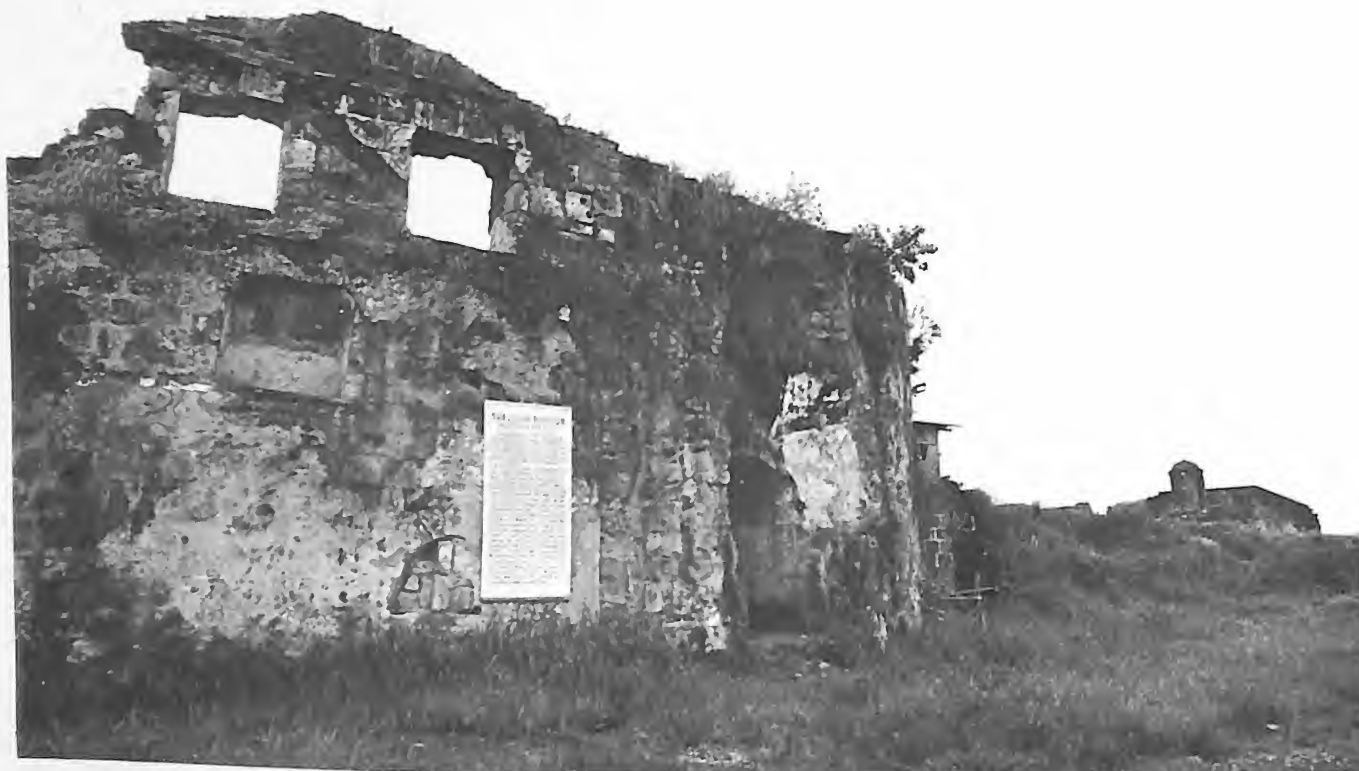
Figure 42. *The forlorn ruins of the Bastión de San Diego as it looked in September 1979. Its one surviving garita keeps a lonely watch on the north flank.*

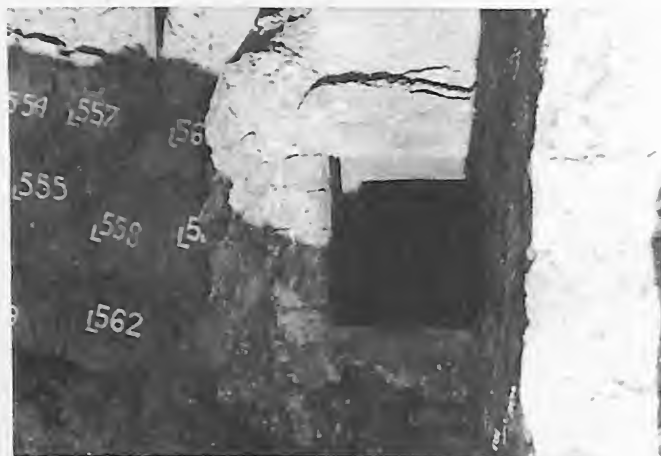
Figure 57. Aperture of the manhole or tunnel located on the northeast portion of the circular structure. It has a vertical entrance, three meters deep, sealed off by a large stone slab. The tunnel runs northeast for only two meters, stopping where a cave-in has occurred. It is assumed that this opening had been pried loose in the last decade because of the presence of contemporary materials like rubber slippers, plastic comb, tin cans and Garand clip.

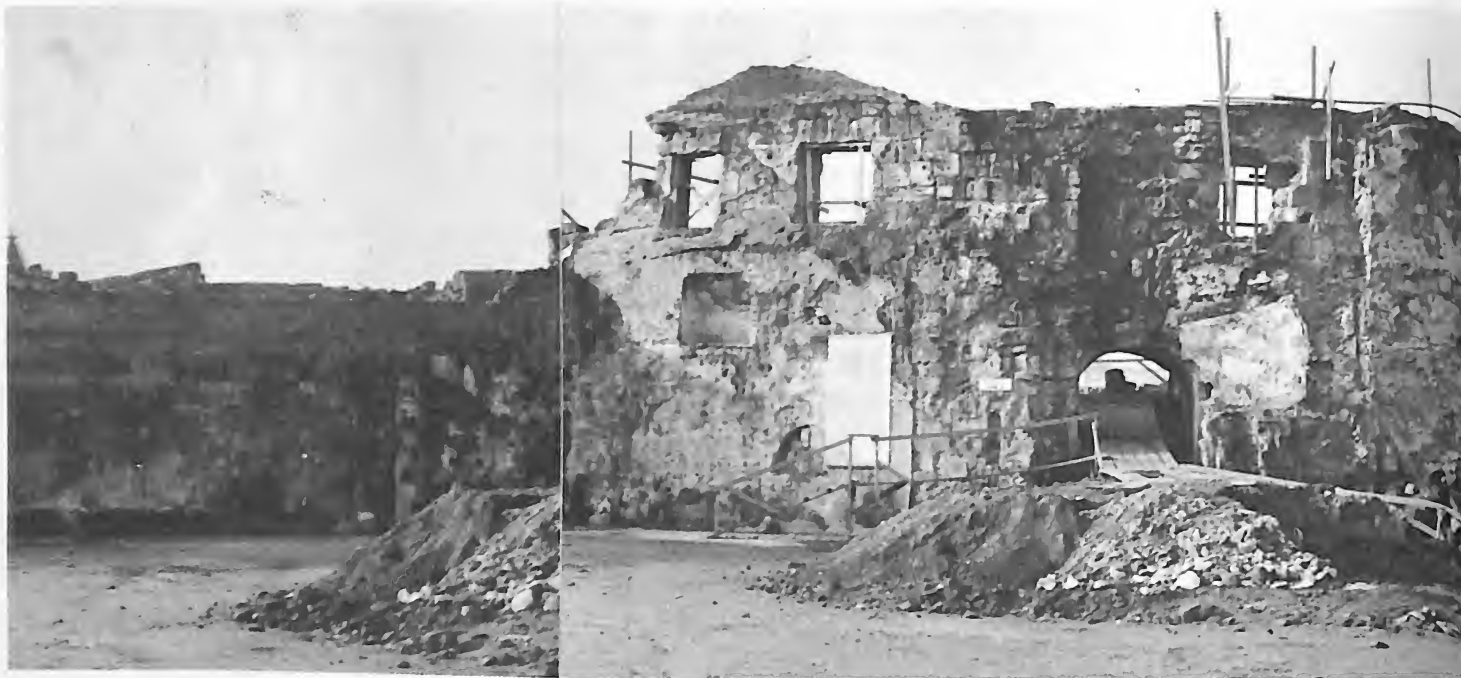
Photograph shows the condition of the west flank. The central portion of the drawing shows how mojones—landmarks—were used to shore up eroding portion of the wall.

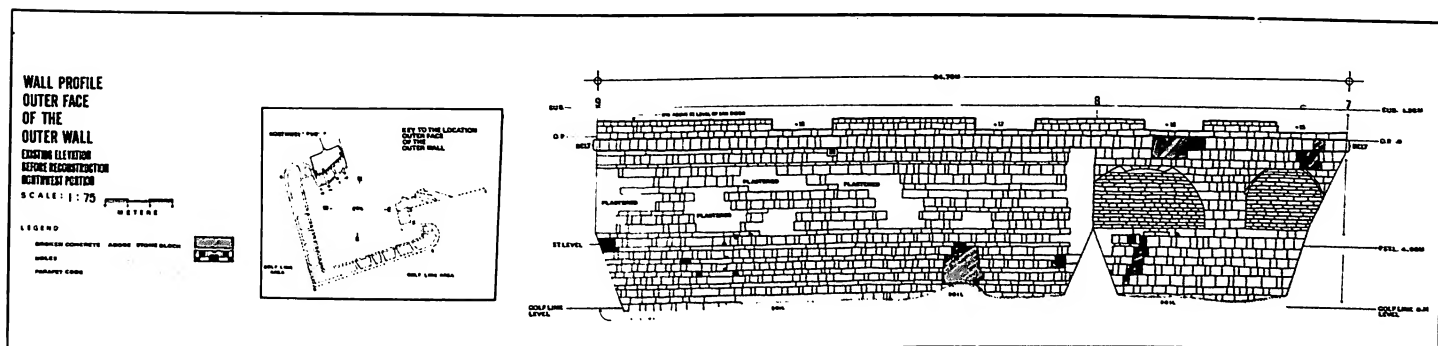
*Existing elevation and status of the wall before reconstruction of the northwest portion.*
